Malak Malak River Monitoring Report: 2009 – 2010

Marcus Finn, Pippa Featherston and the Malak Malak Land Management Rangers

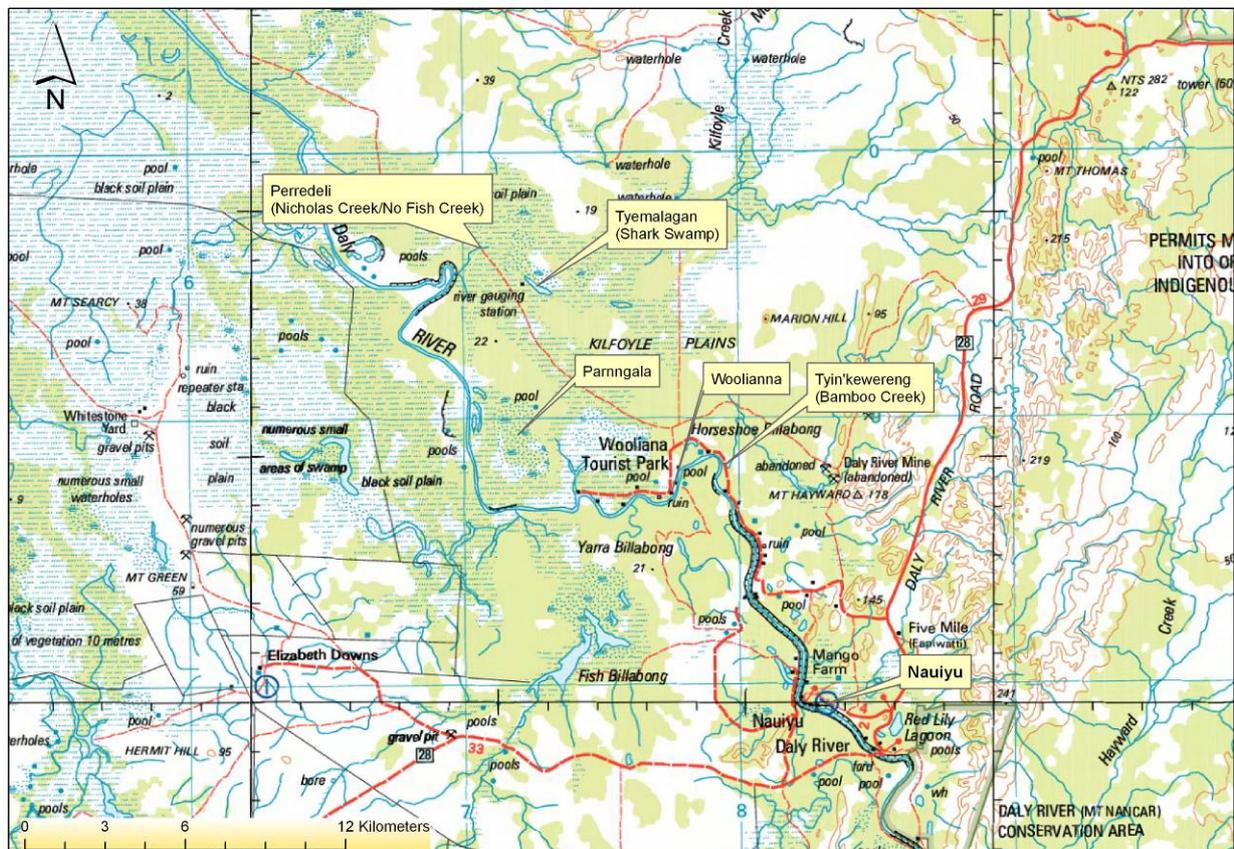
Figure 1: Location of monitoring sites and Woolianna community.

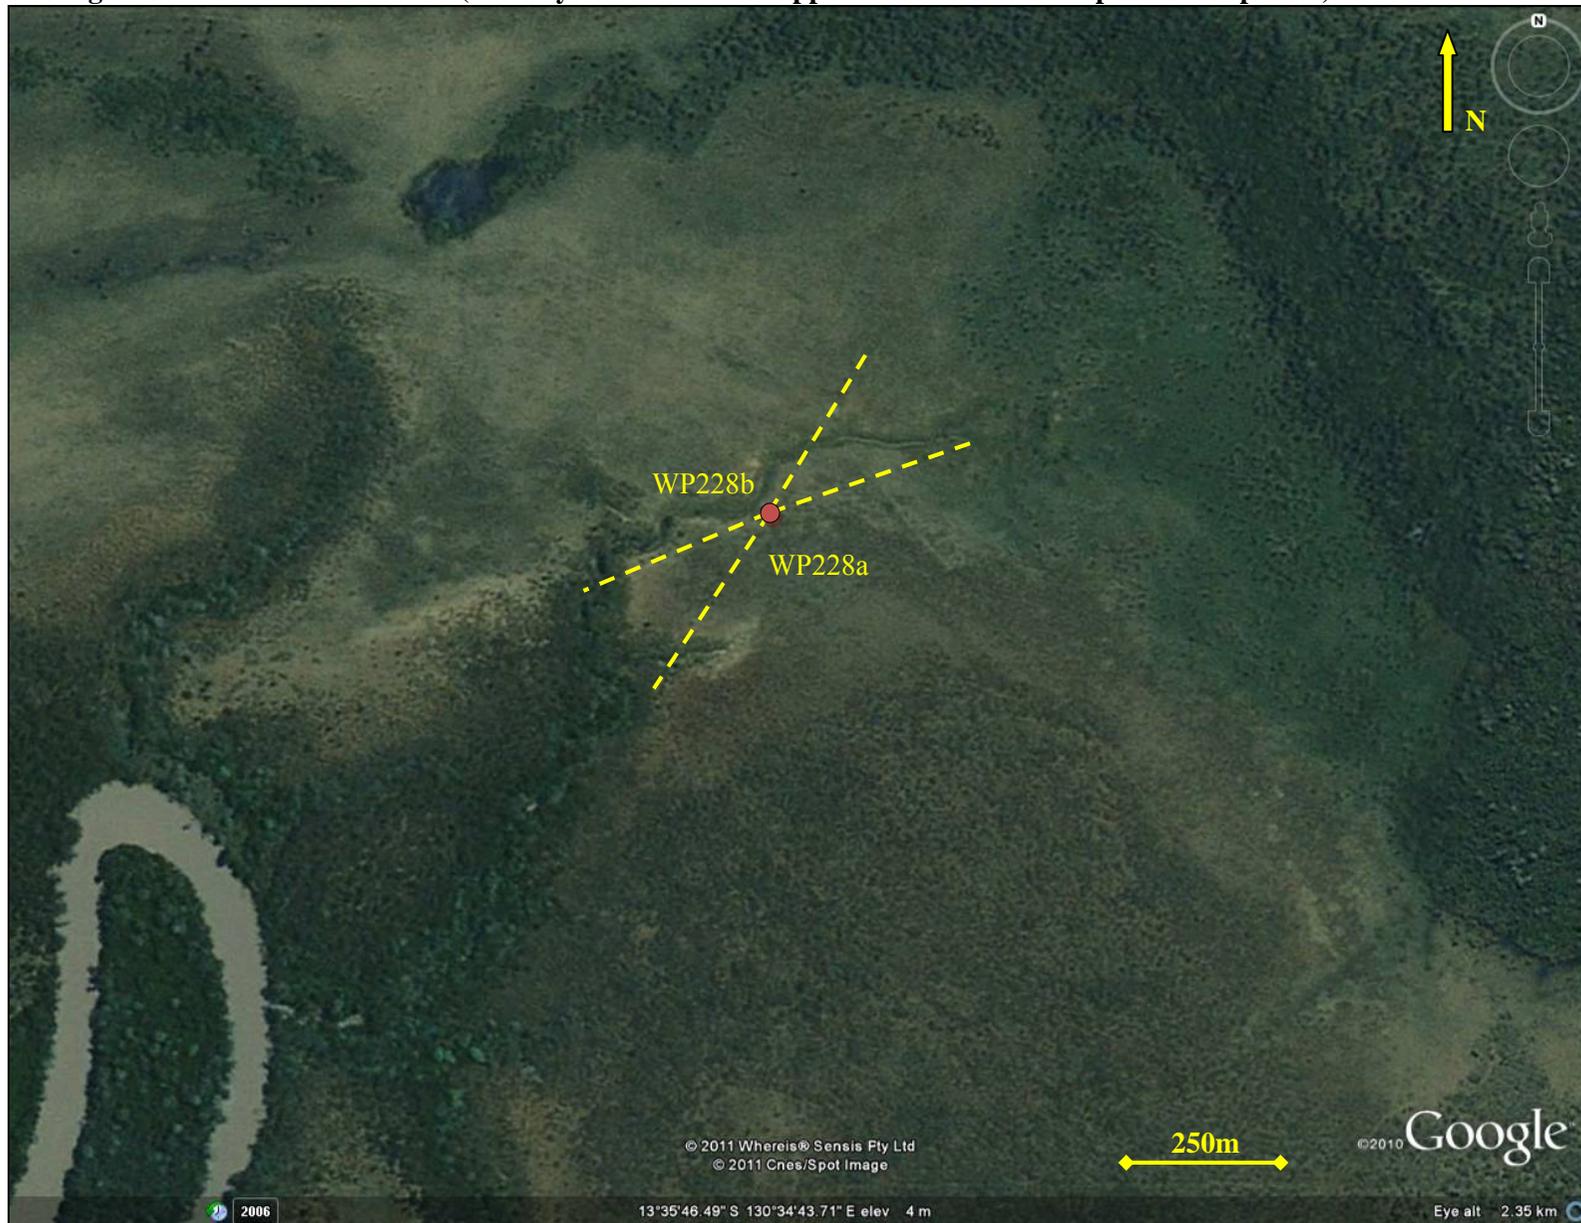
Perredeli (WP228a): August 2010

A Google Earth™ view of Perredeli (dotted yellow lines show approximate direction of permanent photos)

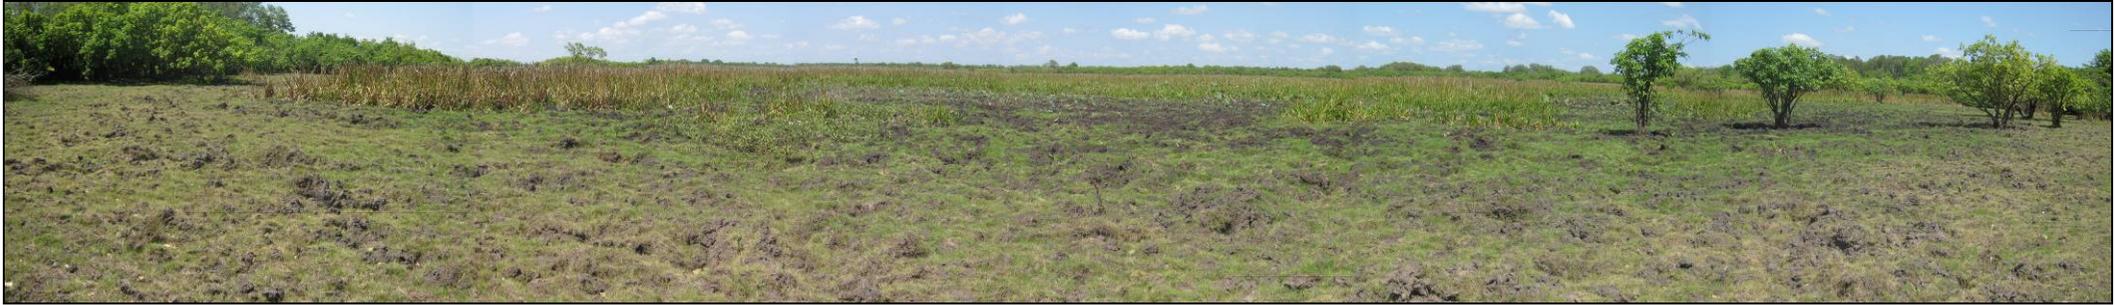
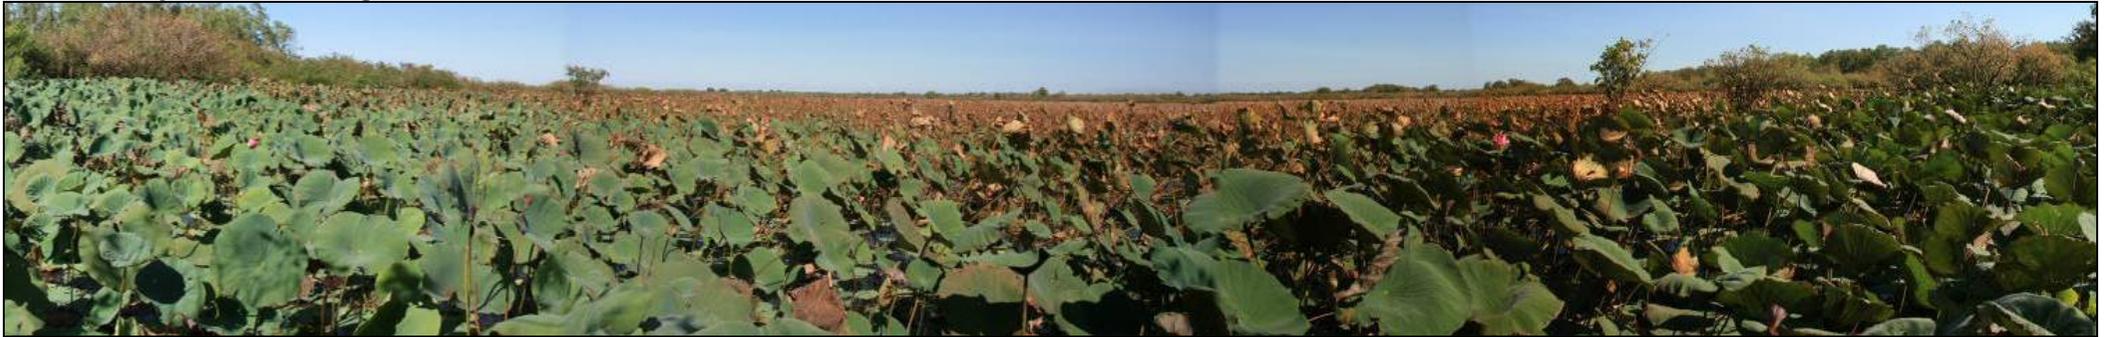
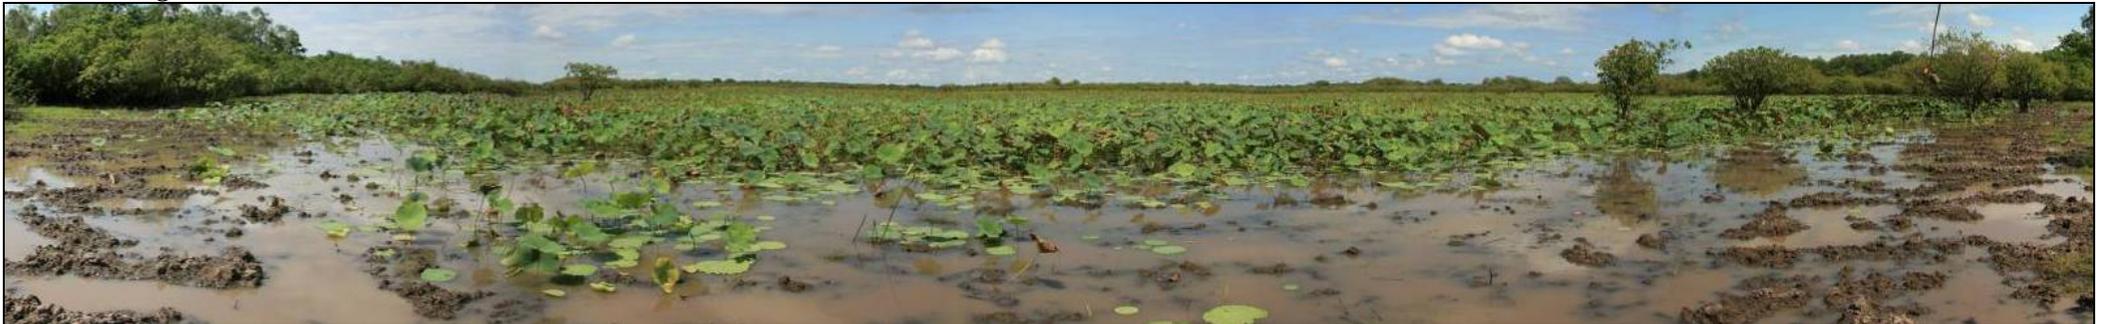
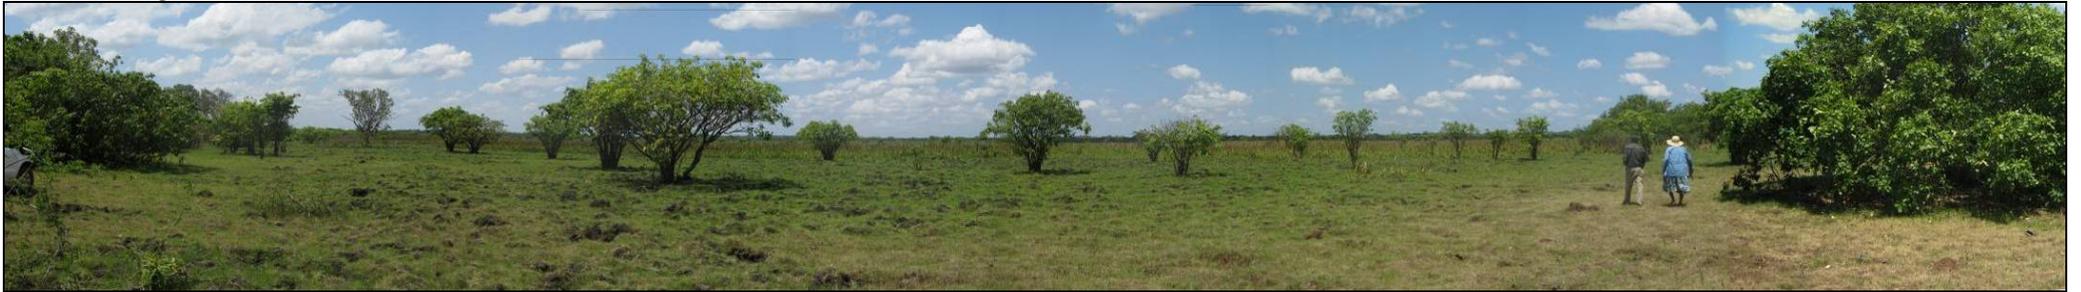
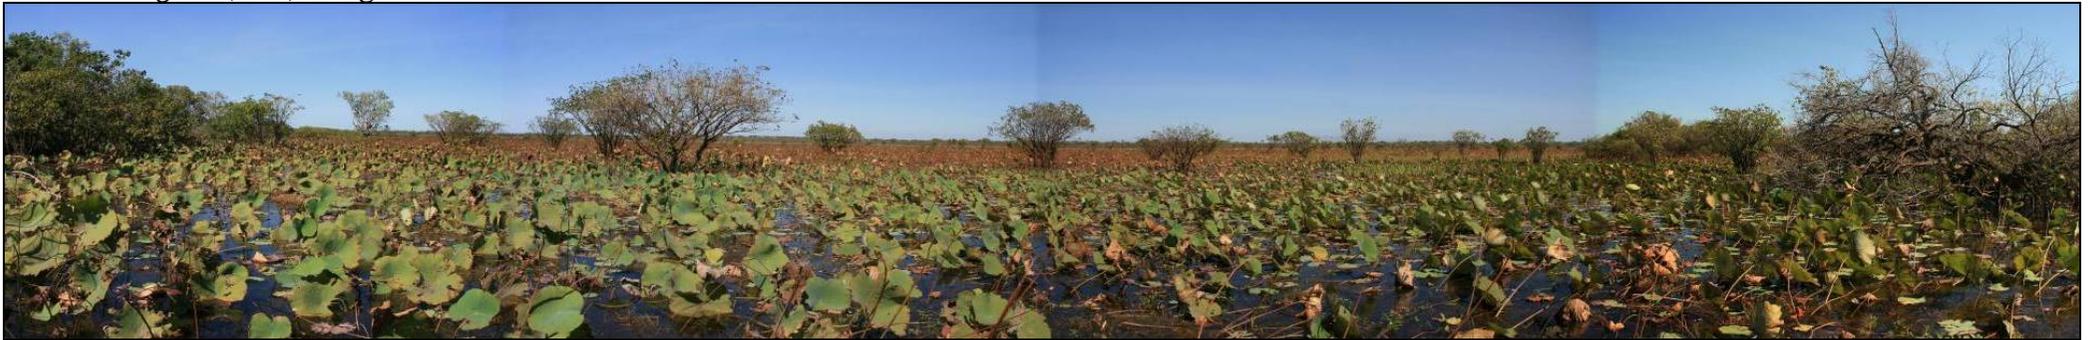
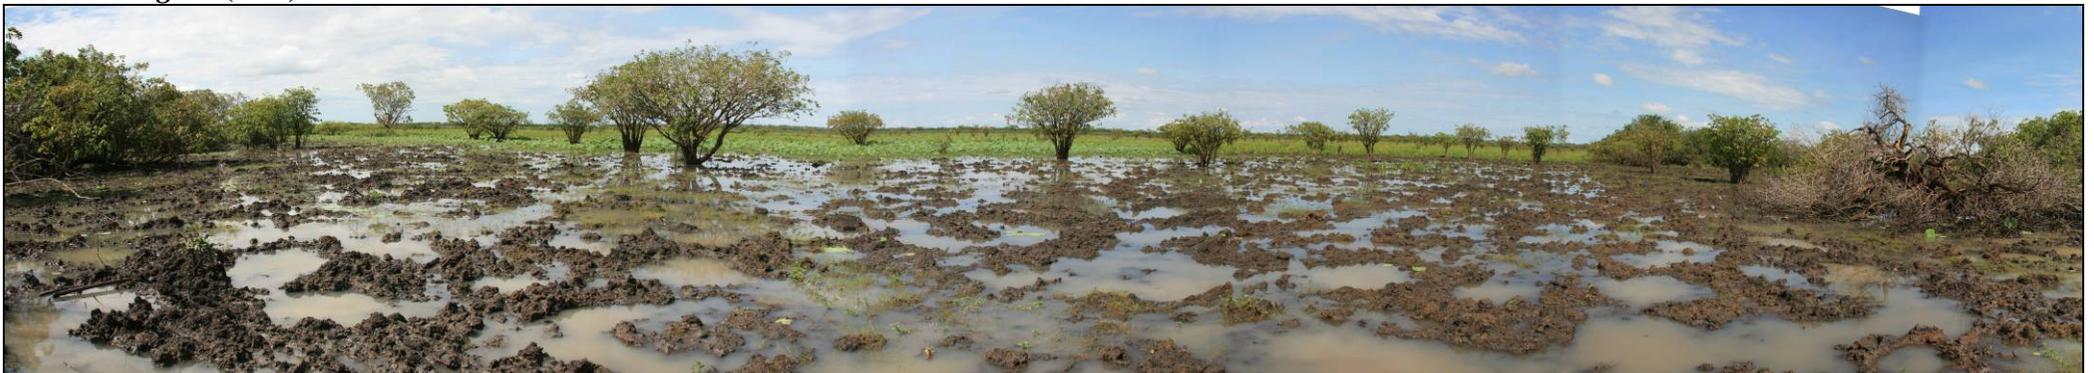
The permanent photo points at *Parnngala* show the dramatic seasonal changes that occur over the space of a year. Photos taken in November 2009 show little water and evidence of prior pig damage, especially at site PP1. After the wet season, Lotus Lilies (*N. nucifera*) regrow in *Parnngala* (seen in August 2010). At this time the density of lilies is very high.

As the water recedes during the dry season, the edges are dug up by feral pigs (seen in October 2010). By October 2010 the lilies are disappearing from the edges of the billabongs, possibly as a result of being dug up by feral pigs. There were still lilies present in the middle of *Parnngala* where the water was deeper.

The Rangers say the billabong used to be clearer, and fill up with water right to top. They have also noticed changes in the trees growing at the edge of *Parnngala*, which are denser and make access to the billabong problematic.

The Rangers suggest that the majority of changes seen at *Parnngala* are the result of feral animals. The permanent photos taken in August and October 2010 suggest how many lilies the pigs eat and push over by the end of the dry season. The Rangers say that because the pigs and buffalo push the ground into mounds and holes, they now see the lilies growing in sideways directions instead of straight up and wonder if it is affecting the health of the plant. It is also believed that the cattle and other animals urinating in the water burns the lilies and make them grow haphazardly. The Rangers also note that the lilies shown in these permanent photos are shorter than in other years and should be longer, although an explanation was not given.

- <i>Water level:</i>	3/3	●	
- <i>Cattle/Pig damage:</i>	1/3	●	Extensive pig digging removing vegetation and disturbing soil
- <i>Vegetation health:</i>	1/3	●	
- <i>Soil condition:</i>	1/3	●	
- <i>Weeds:</i>	2/3	●	
<u><i>Total</i></u>	<u>8/15 (53%)</u>

The management interventions the Rangers would like to see at *Parnngala* include preventing the access of cattle, buffalo and pigs and continuing the control of Mimosa.

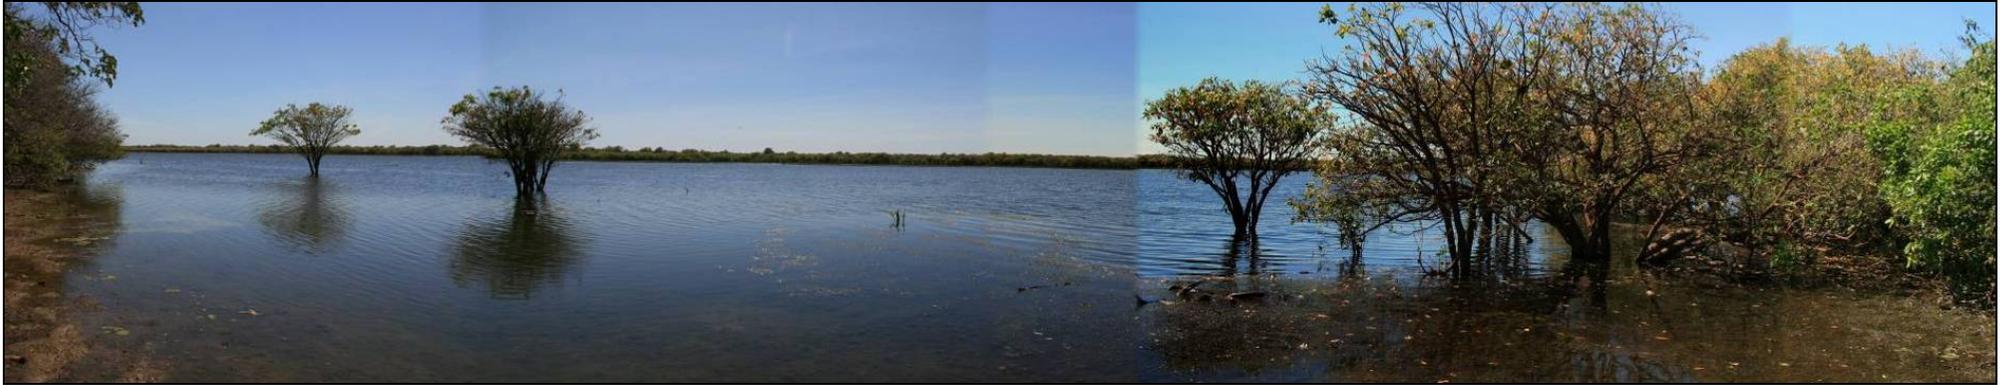
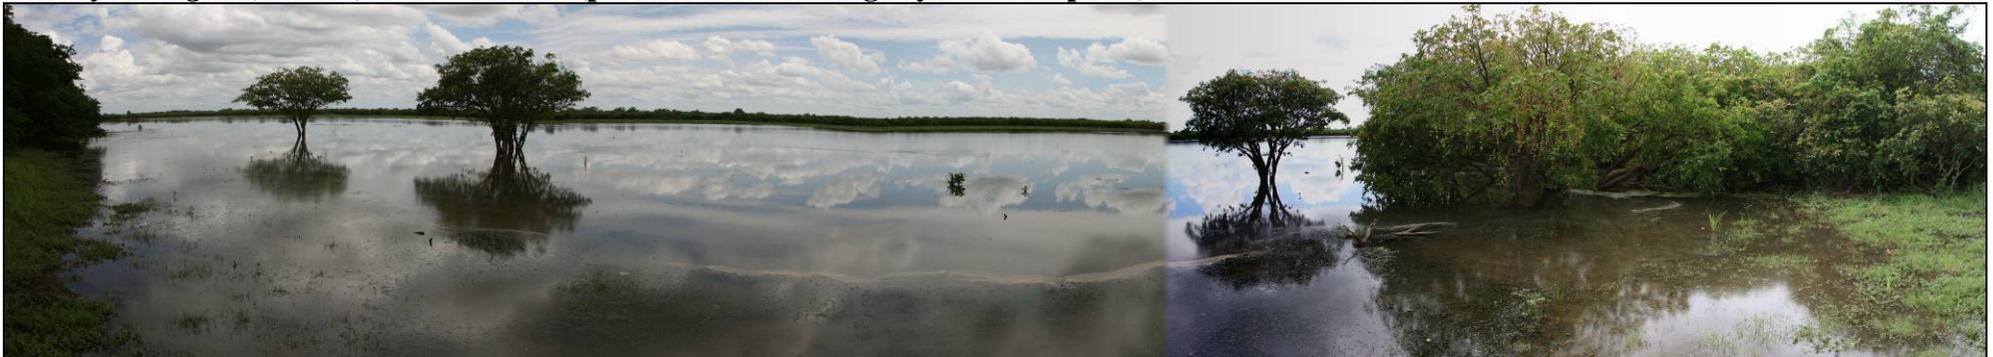
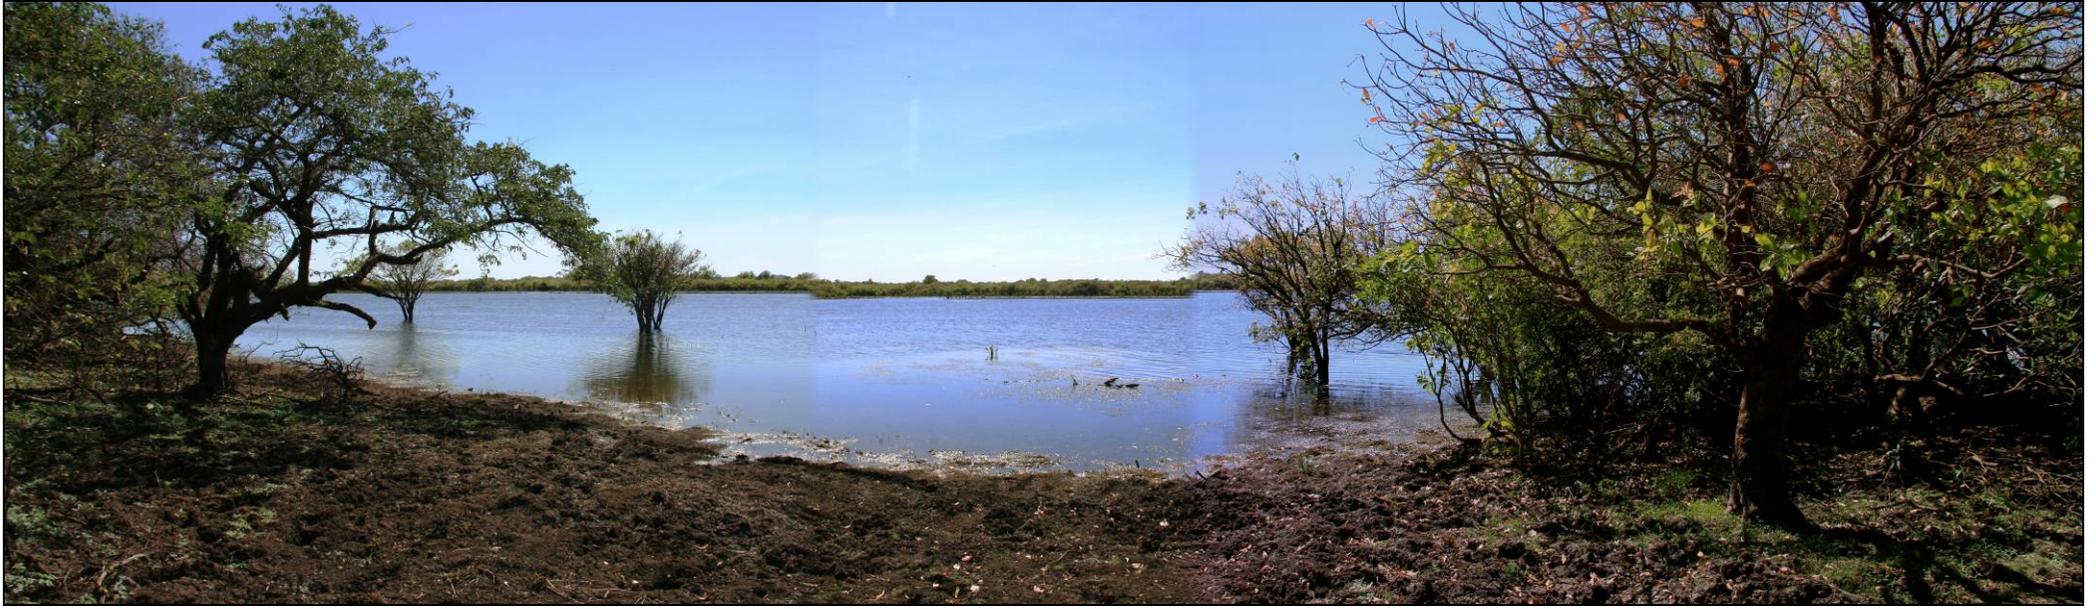
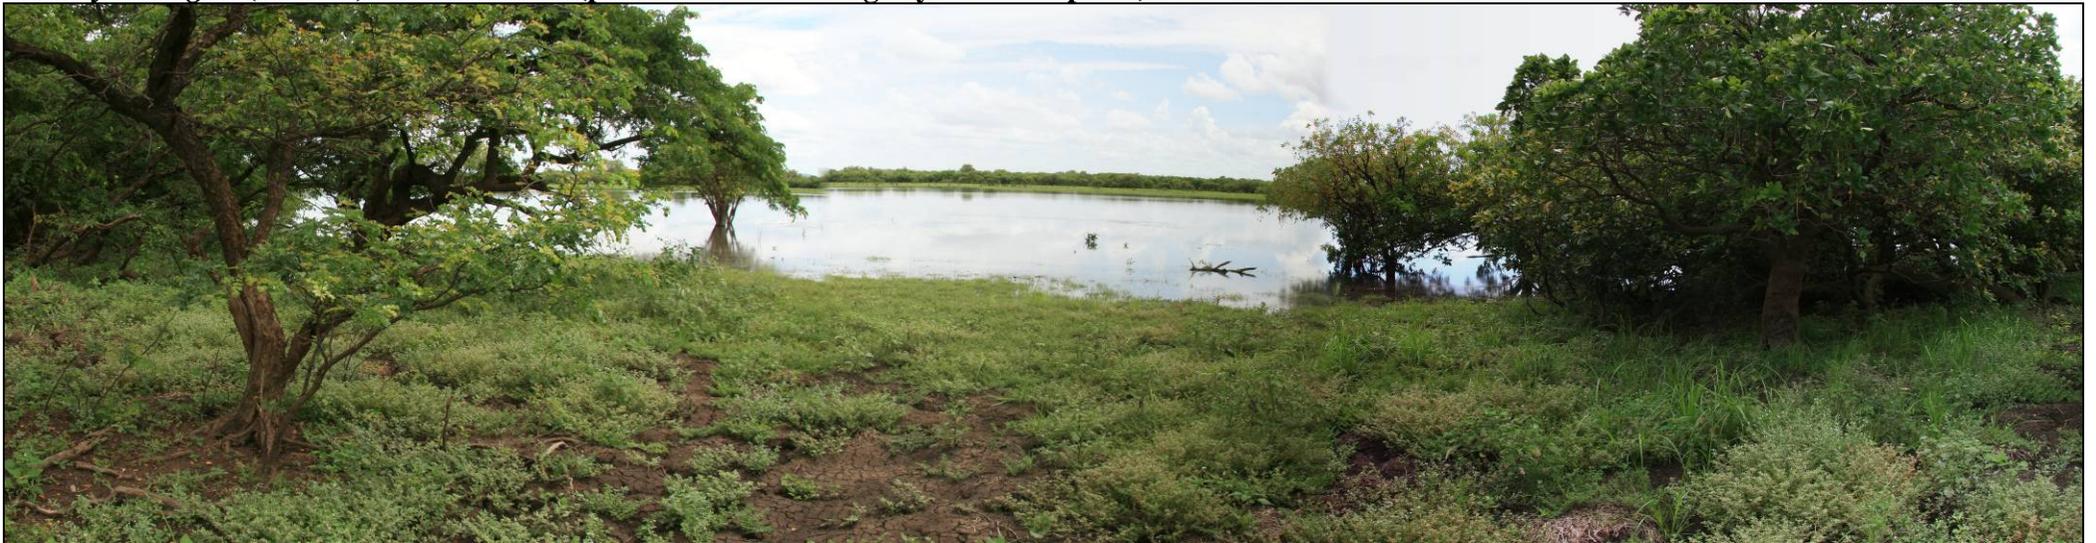
Permanent photo-points were taken at *Tyemalagan* in August and October 2010. Ground cover increased, and canopy cover of bank-side trees thickened at both photo points during the three months between captures.

The Rangers believe *Tyemalagan* is silting up and are quite concerned. They recall *Tyemalagan* having Lotus Lilies in the past, something that no longer happens due to cattle, pigs and buffalo. Water quality appears to be poor. The water goes green through the dry season, and is often dirty. It used to be clear and blue. The Rangers suggest this is as a result of cattle and pigs, and also the large number of water birds that mess the water up.

- <i>Water level:</i>	3/3	●	
- <i>Cattle/Pig damage:</i>	2/3	●	
- <i>Water quality/colour:</i>	1/3	●	Clear decline in living memory
- <i>Vegetation health:</i>	3/3	●	
- <i>Weeds:</i>	3/3	●	
<u><i>Total</i></u>	<u>12/15 (80%)</u>

The Rangers suggest the fencing of cattle from *Tyemalagan* may be a first step in management intervention for the area. They have asked the near-by station owner to muster the cattle and keep them inside the neighbouring property. The Rangers would also like to continue to work on the control and removal of Mimosa.

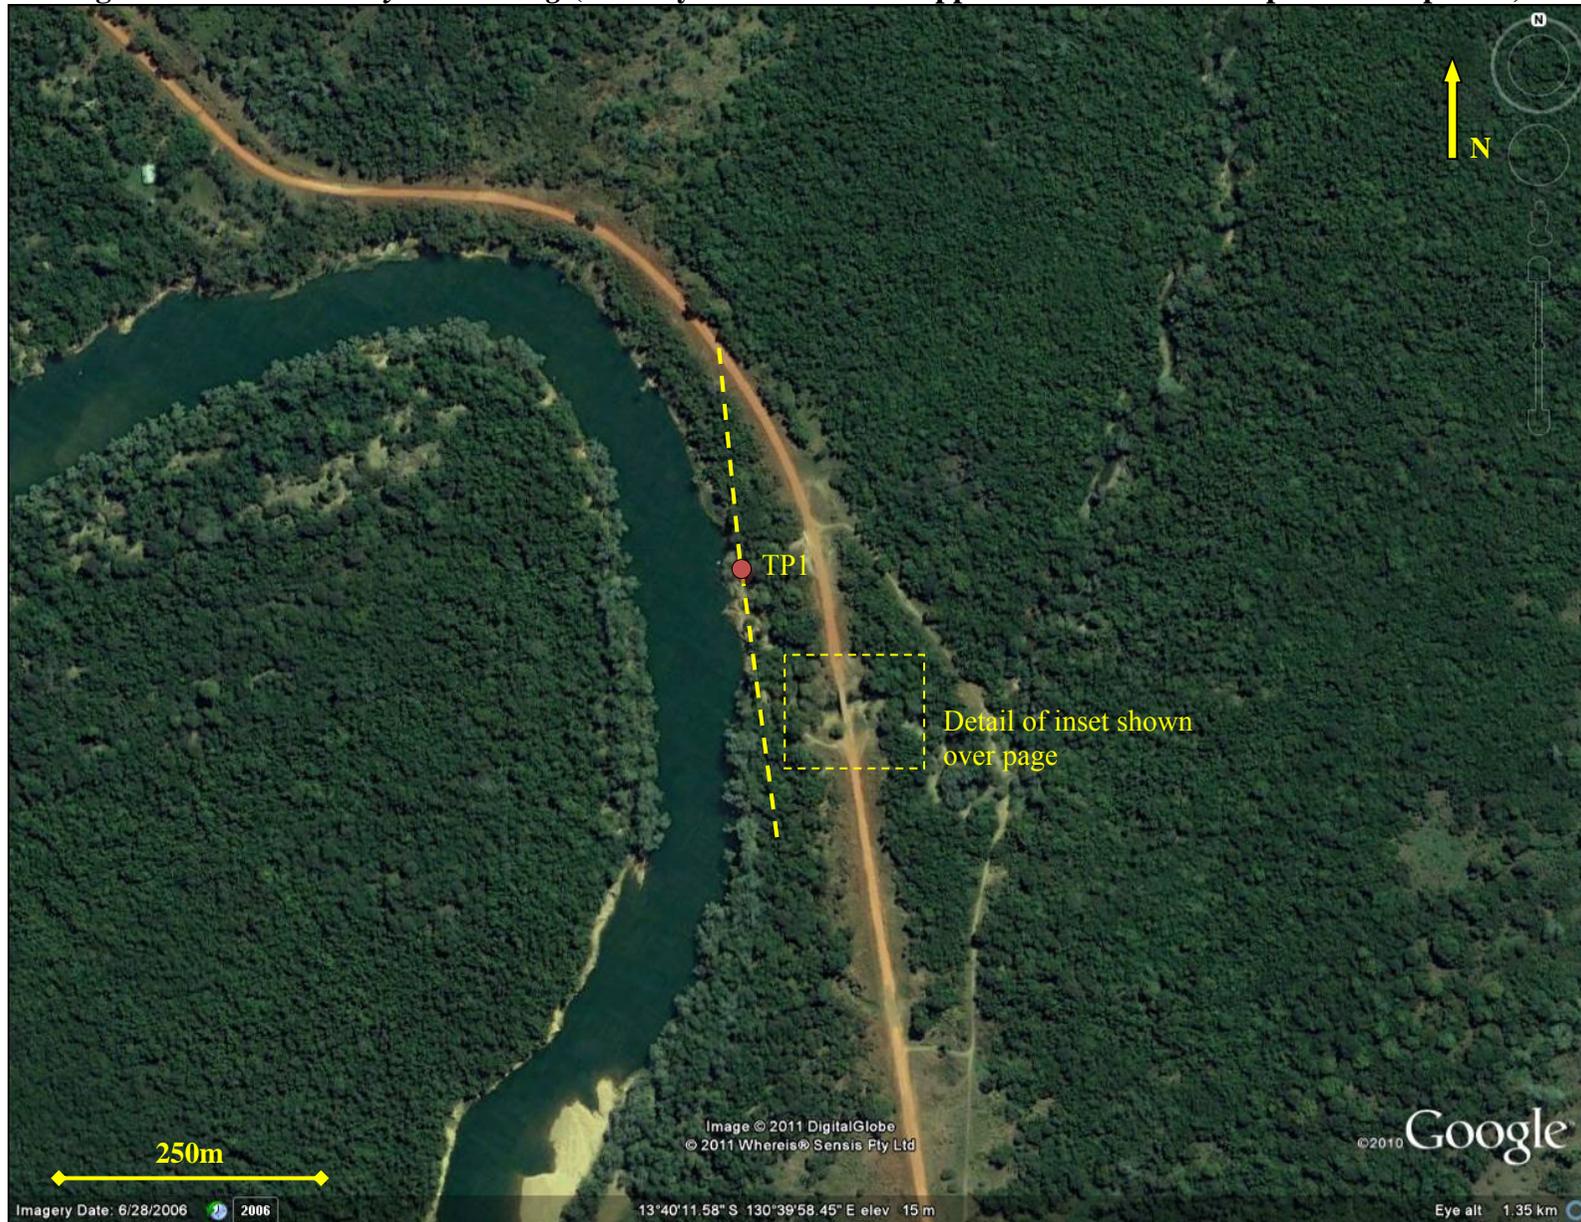
A Google Earth™ view of *Tyin'kewereng* (dotted yellow lines show approximate direction of permanent photos)

Six permanent photo points were established at *Tyin'kewereng* to monitor bank condition, erosion (especially near the mouth), and sedimentation. Permanent photo points TP1, TP1-1 and TP1-2 focus on the mouth of Bamboo Creek where it joins the Daly River, while TP2, TP3, TP4 and TP5 capture Bamboo Creek from the Woolianna Road bridge.

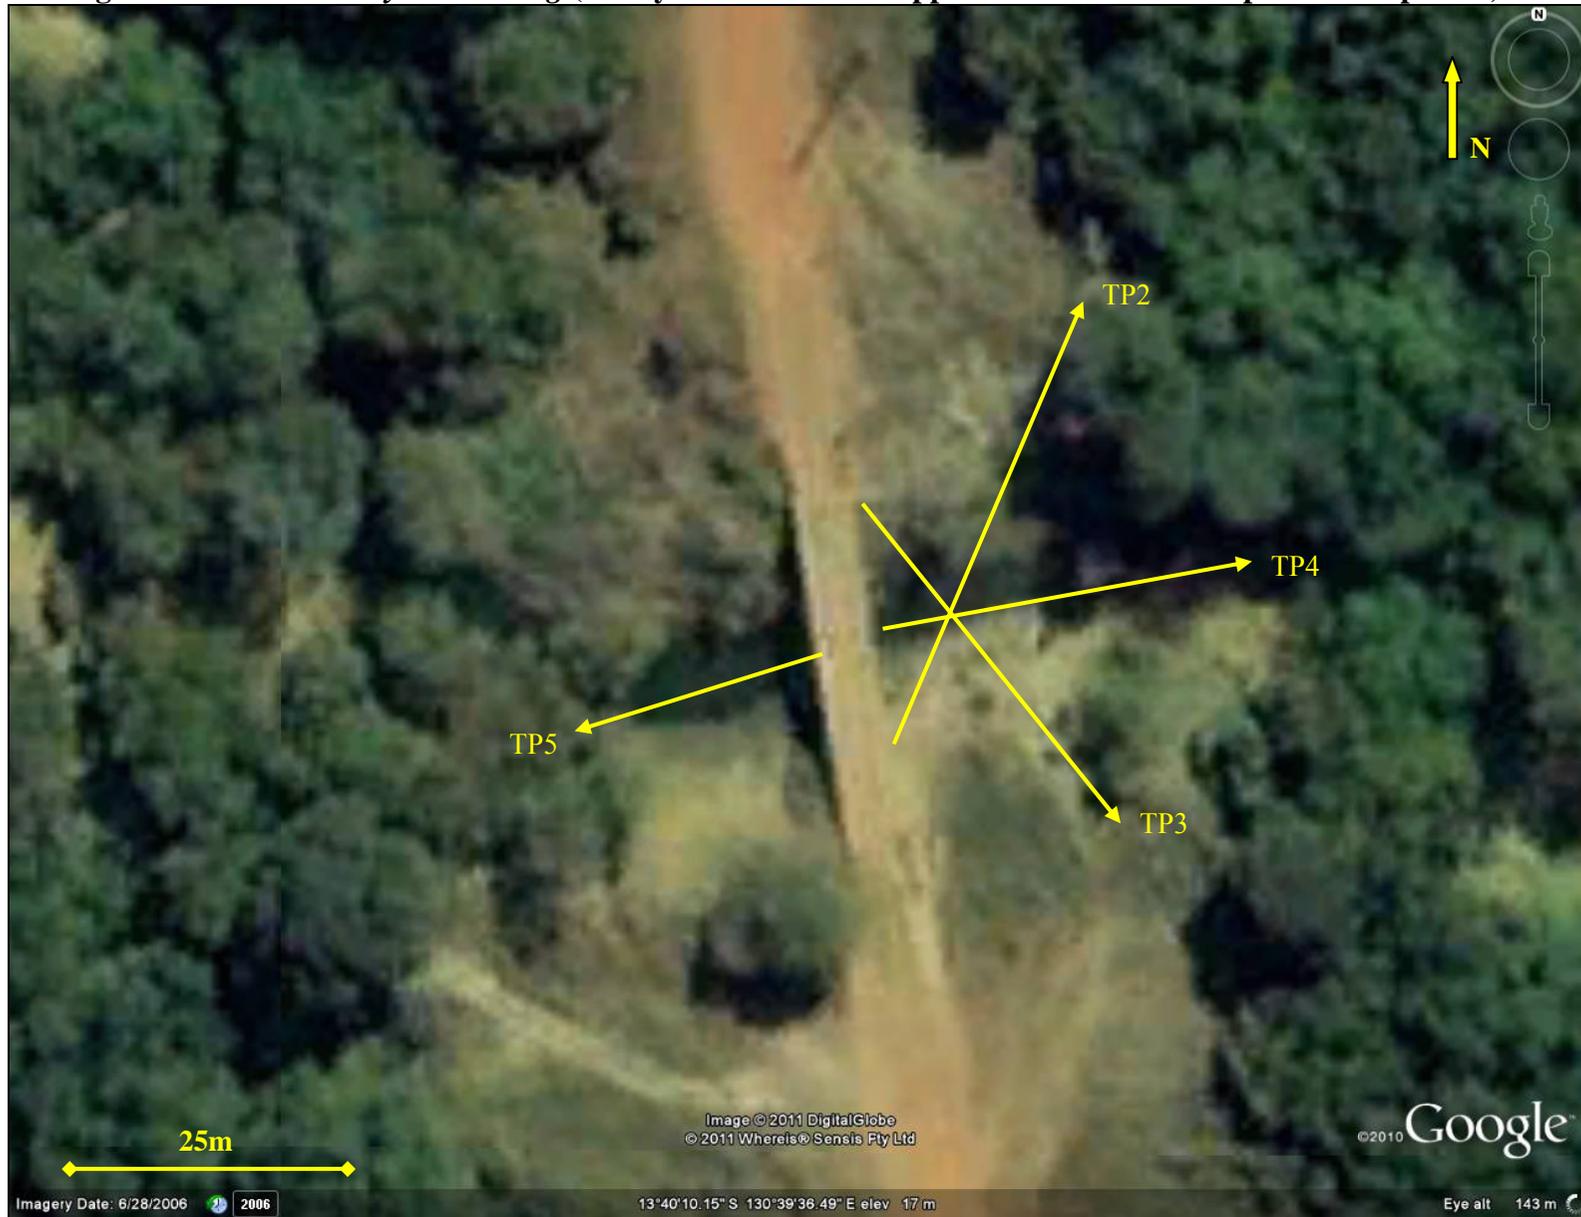
A Google Earth™ view of *Tyin'kwereng* (solid yellow lines show approximate direction of permanent photos)

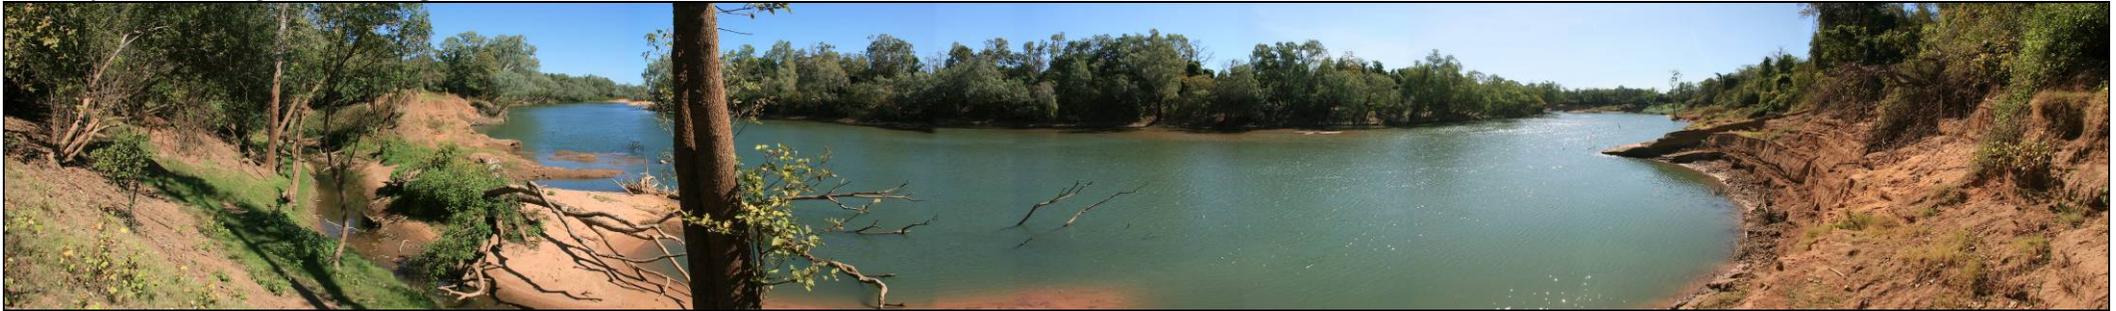
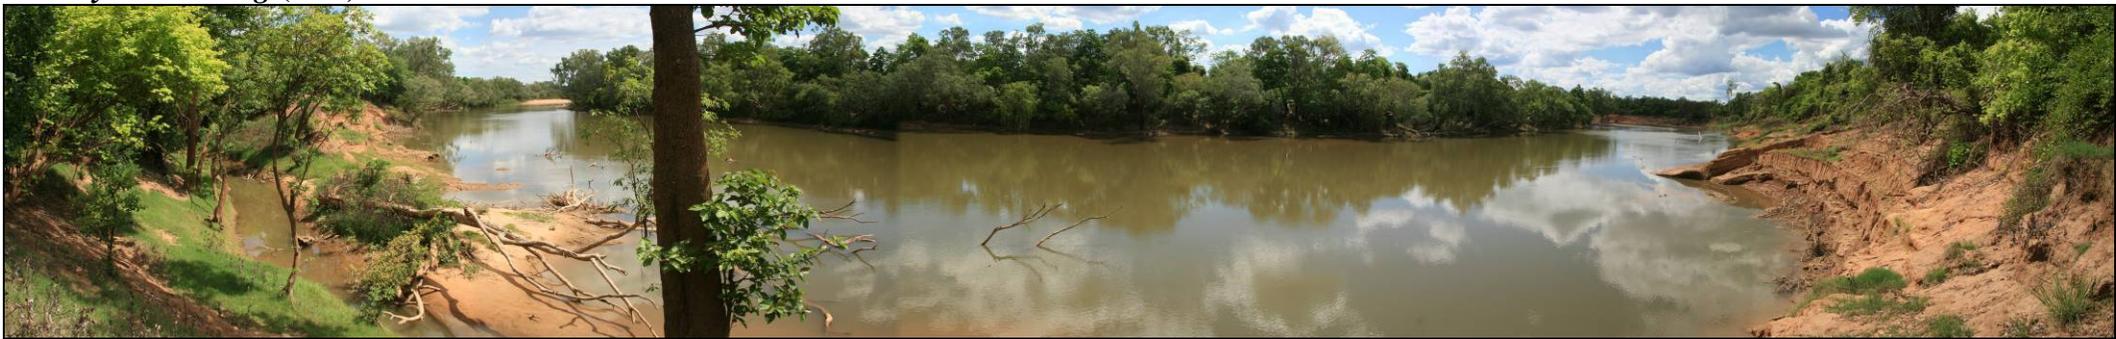
Photos taken from TP1 and stitched together suggest a small increase in water level between August and October 2010, probably as a result of rainfall slightly before the October sampling trip. Photos from TP2, TP3, TP4 and TP5 also suggest there was a flush of water down the creek and river between August and October 2010. Vegetation and sediment has been removed from the bed of the creek between these dates, and a shrub has been washed out of the centre of the photo of TP2. The photos also show some die-back (or washing away) of Noogoora Burr between August and October.

TP1 shows a substantial bank slump downstream of the creek mouth. This area of bank slump is very near a place where Malak Malak people used to camp. Over the year of permanent photos at this location, the area of erosion did not appear to get larger or change in any way. This period of time included a wet season, where water levels were at the top of the bank and there were substantial erosive forces.

The Rangers have already started management intervention for *Tyin'kewereng*. They would like to keep cars and caravans away from the river bank to prevent further erosion and have the area blocked off. They are also managing Noogoora Burr at times by poisoning.

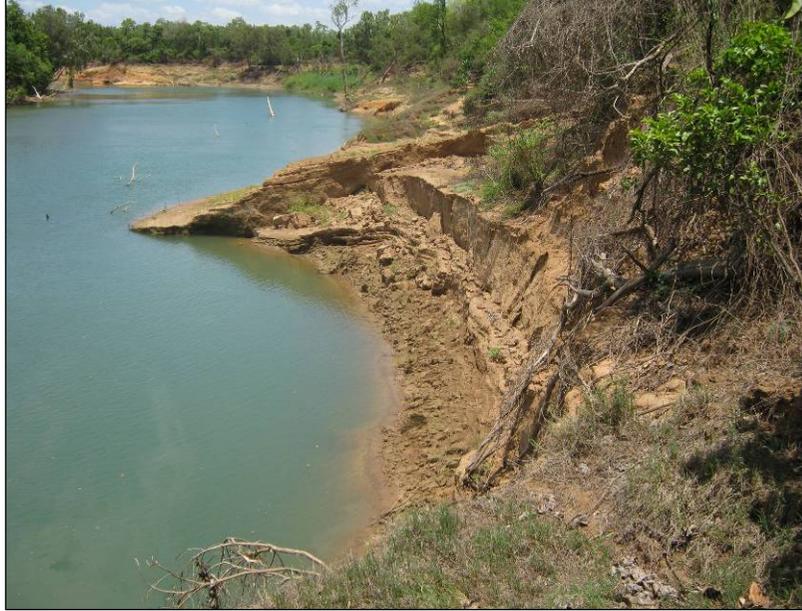
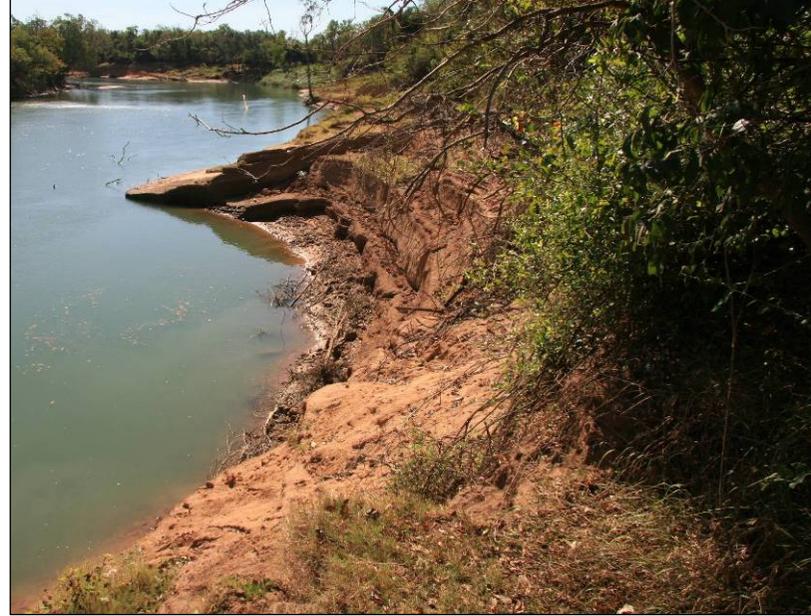
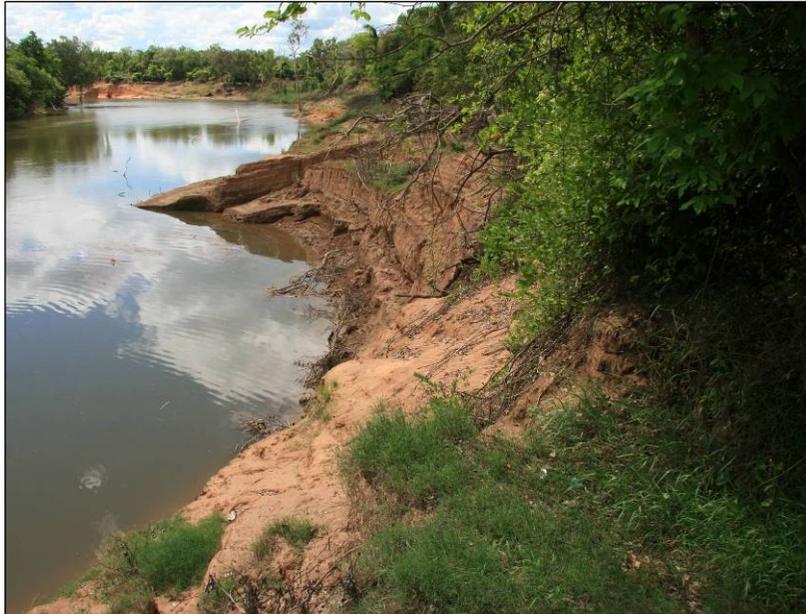
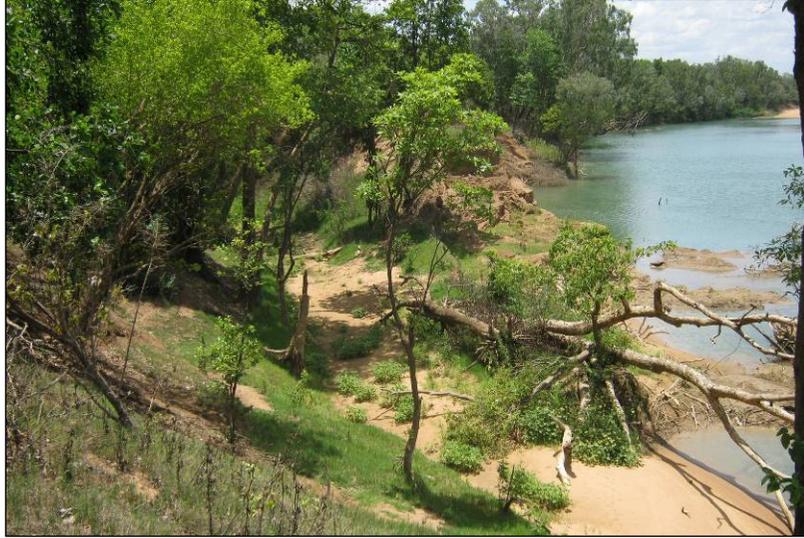
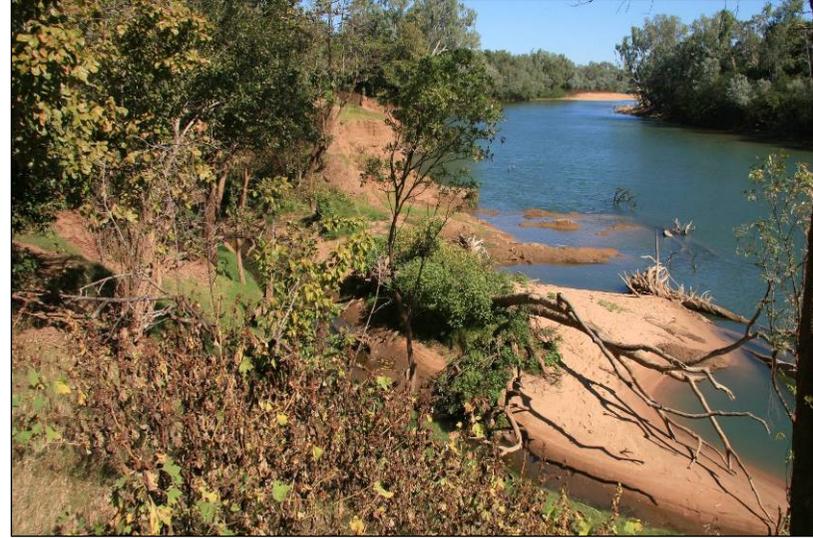
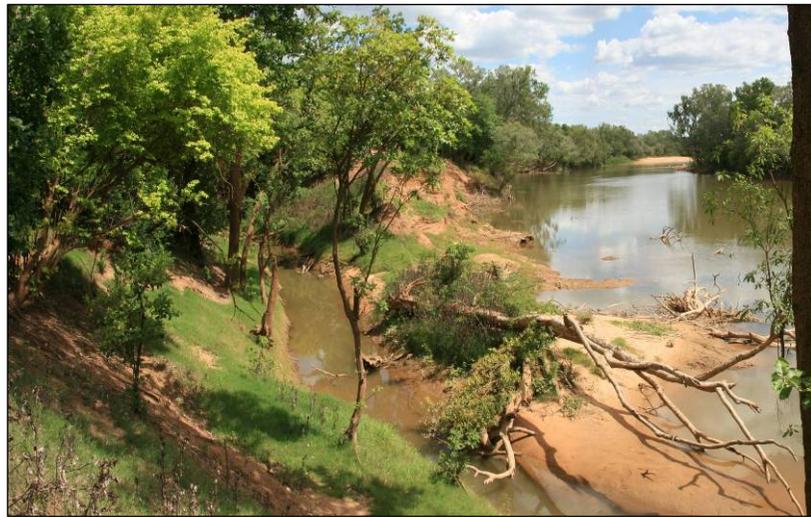
Photos were taken at TP1-1, TP1-2, TP2, TP3, TP4 and TP5 in November 2009, August 2010 and October 2010. So, these locations are shown over the course of a year. Almost all photos points (TP1-2, TP2, TP3, TP4 and TP5) show the cycle of Noogoora Burr growth. The first photos in November 2009 show little obvious Noogoora Burr. Subsequent photos during August 2010 show extensive stands of dry Noogoora Burr, suggesting that the plant has regrown and gone to seed between these times. Few plants are still present in November 2010. However, photo points TP2 and TP4 suggest that grasses providing close ground cover do not grow well under stands of Noogoora Burr. This would suggest that Noogoora Burr may promote the erosion of banks (by out-competing low grasses, but dying back prior to the wet season and exposing the soil), although more specific work is required for confirmation.

The Rangers are concerned that the mud that helps hold the banks together is washing into the river, leaving just sand and gravel and making the banks unstable. The Rangers used the colour of the dirt in the photographs to indicate whether the soils were good. Light brown dirt suggests the soil is very powdery, and is capable of being washed away. Darker brown soil suggests the presence of black soil or clays that stabilise the bank and make them more resistant to erosion. TRaCK research on the lower Daly River suggests there has been considerable erosion of riverbanks due to large wet season flows over the last 20-30 years. These large flows are likely due to the wetter-than-average wet seasons over this period rather than any changes in land-use upstream. However, this increased erosion has led to more sediments being moved throughout the lower Daly River which could also be contributing to observed changes in floodplain waterholes as sediments are moved onto the floodplain during floods.
