Malak Malak River Monitoring Report: 2009 – 2010

Marcus Finn, Pippa Featherston and the Malak Malak Land Management Rangers

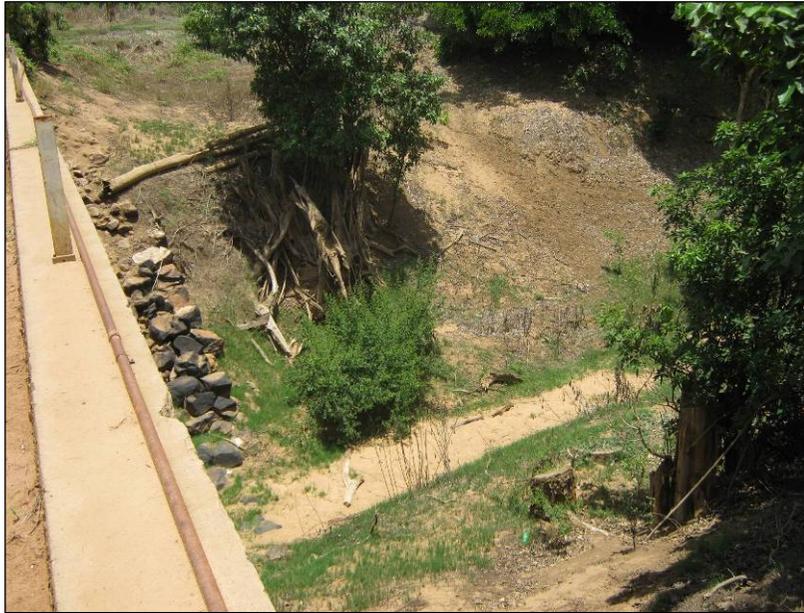
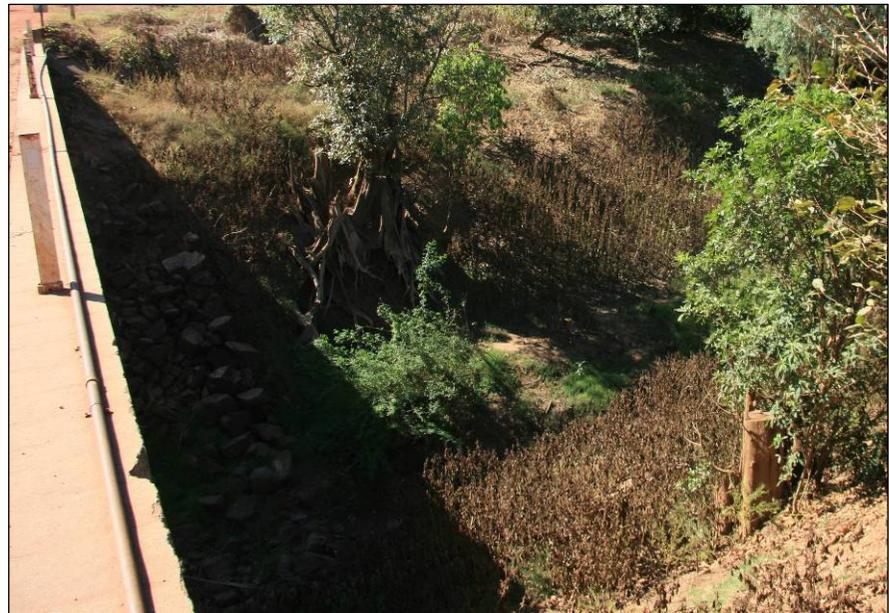
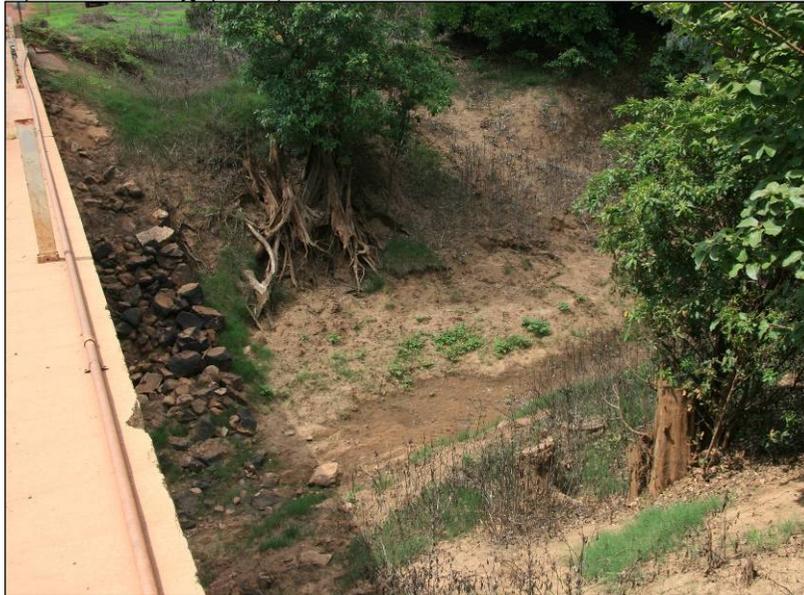
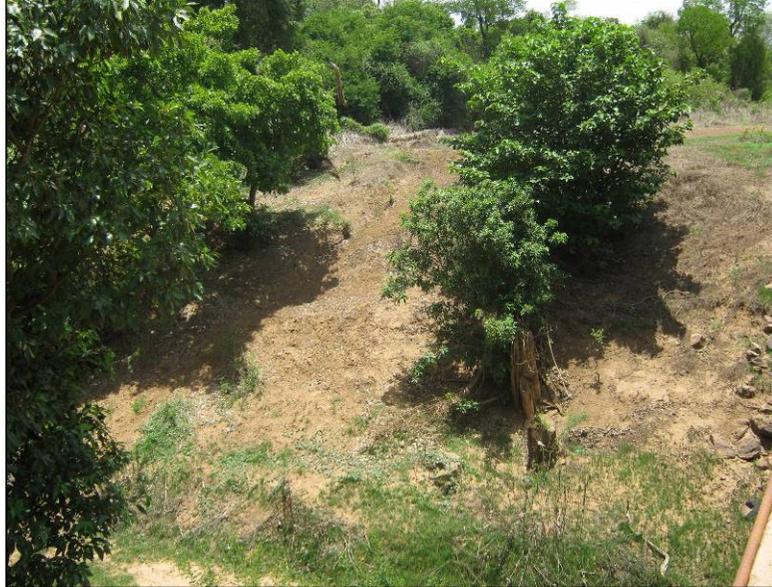
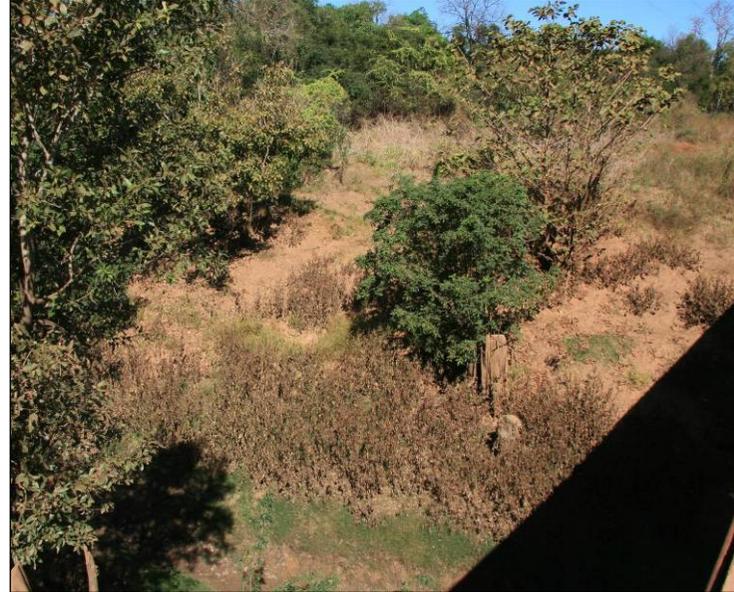
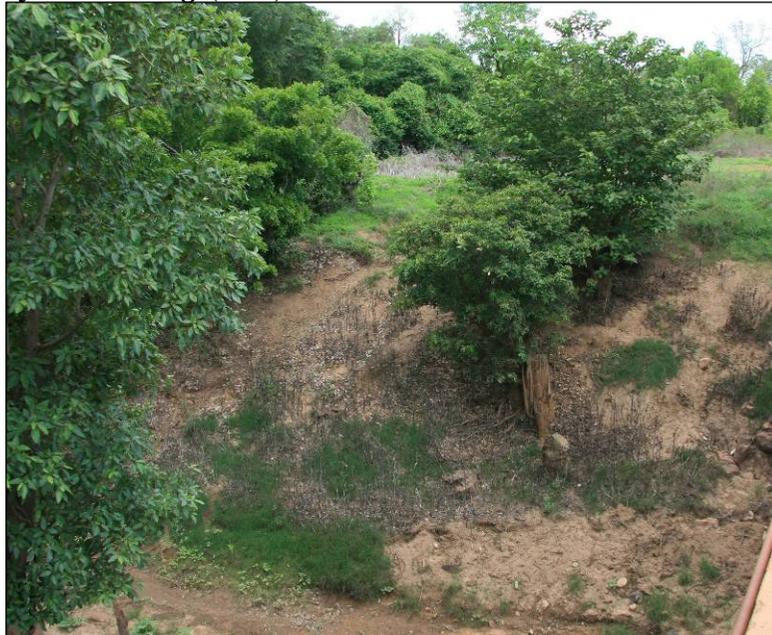
Photos were taken at TP1-1, TP1-2, TP2, TP3, TP4 and TP5 in November 2009, August 2010 and October 2010. So, these locations are shown over the course of a year. Almost all photos points (TP1-2, TP2, TP3, TP4 and TP5) show the cycle of Noogoora Burr growth. The first photos in November 2009 show little obvious Noogoora Burr. Subsequent photos during August 2010 show extensive stands of dry Noogoora Burr, suggesting that the plant has regrown and gone to seed between these times. Few plants are still present in November 2010. However, photo points TP2 and TP4 suggest that grasses providing close ground cover do not grow well under stands of Noogoora Burr. This would suggest that Noogoora Burr may promote the erosion of banks (by out-competing low grasses, but dying back prior to the wet season and exposing the soil), although more specific work is required for confirmation.

The Rangers are concerned that the mud that helps hold the banks together is washing into the river, leaving just sand and gravel and making the banks unstable. The Rangers used the colour of the dirt in the photographs to indicate whether the soils were good. Light brown dirt suggests the soil is very powdery, and is capable of being washed away. Darker brown soil suggests the presence of black soil or clays that stabilise the bank and make them more resistant to erosion. TRaCK research on the lower Daly River suggests there has been considerable erosion of riverbanks due to large wet season flows over the last 20-30 years. These large flows are likely due to the wetter-than-average wet seasons over this period rather than any changes in land-use upstream. However, this increased erosion has led to more sediments being moved throughout the lower Daly River which could also be contributing to observed changes in floodplain waterholes as sediments are moved onto the floodplain during floods.

The Rangers have already started management intervention for *Tyin'kewereng*. They would like to keep cars and caravans away from the river bank to prevent further erosion and have the area blocked off. They are also managing Noogoora Burr at times by poisoning.
